RE: Second Quarter 2010 Inspection Report
Star Point Refuse Pile C/007/042

IMPOUNDMENT INSPECTION AND CERTIFIED REPORT

Report Date July 20, 2010
Permit Number C/007/042
Mine Name Star Point Waste Fuel
Company Name Sunnyside Cogeneration Associates

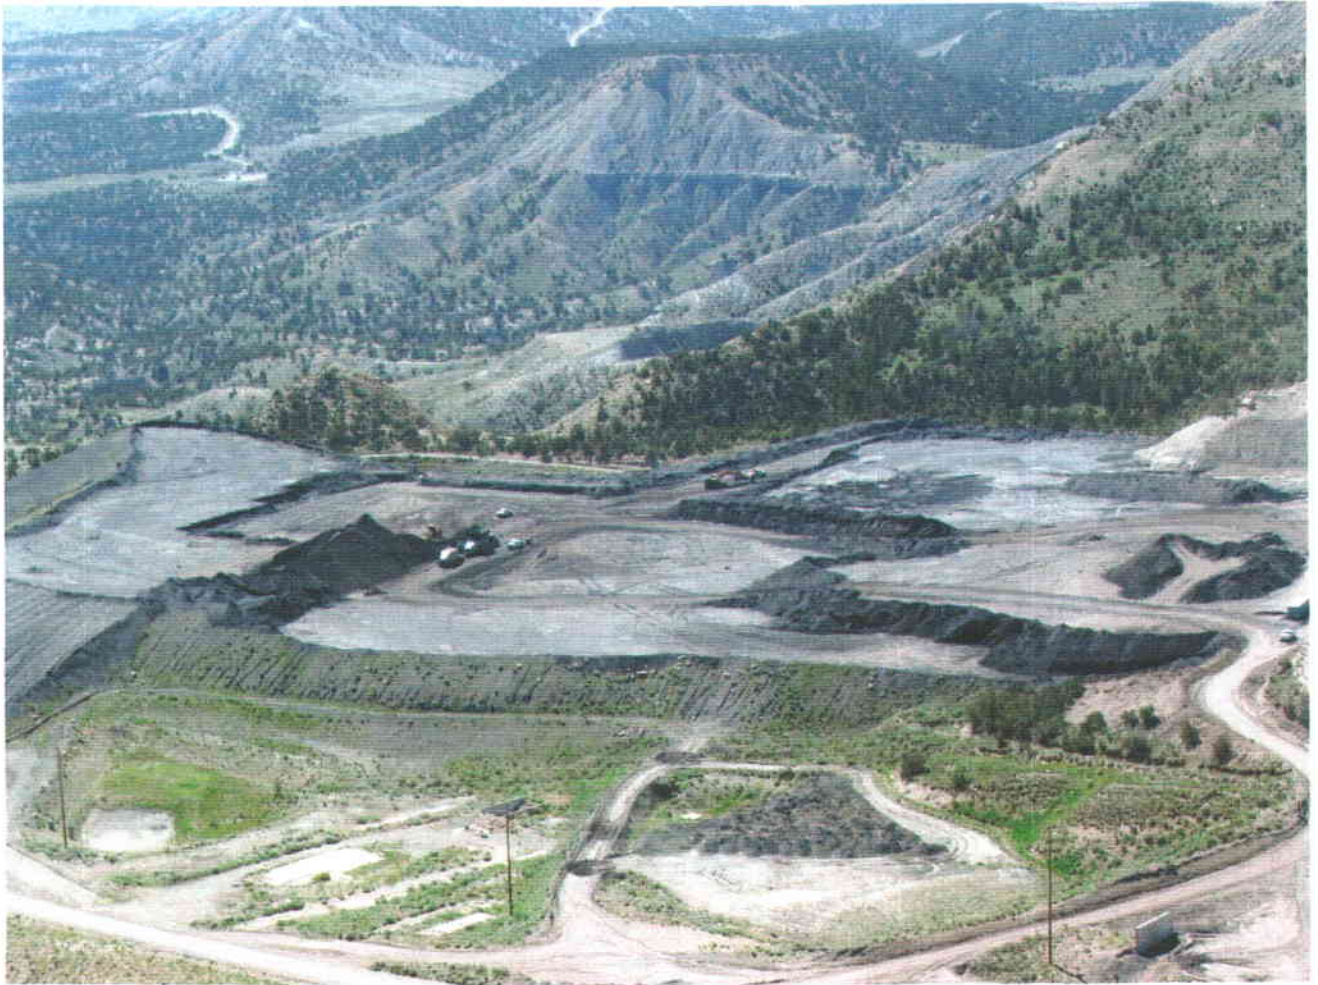
Coarse Refuse Pile A

No aspects of the Fill structure were observed that could affect its stability or functionality

Refuse material is actively being excavated and removed from the top of the pile

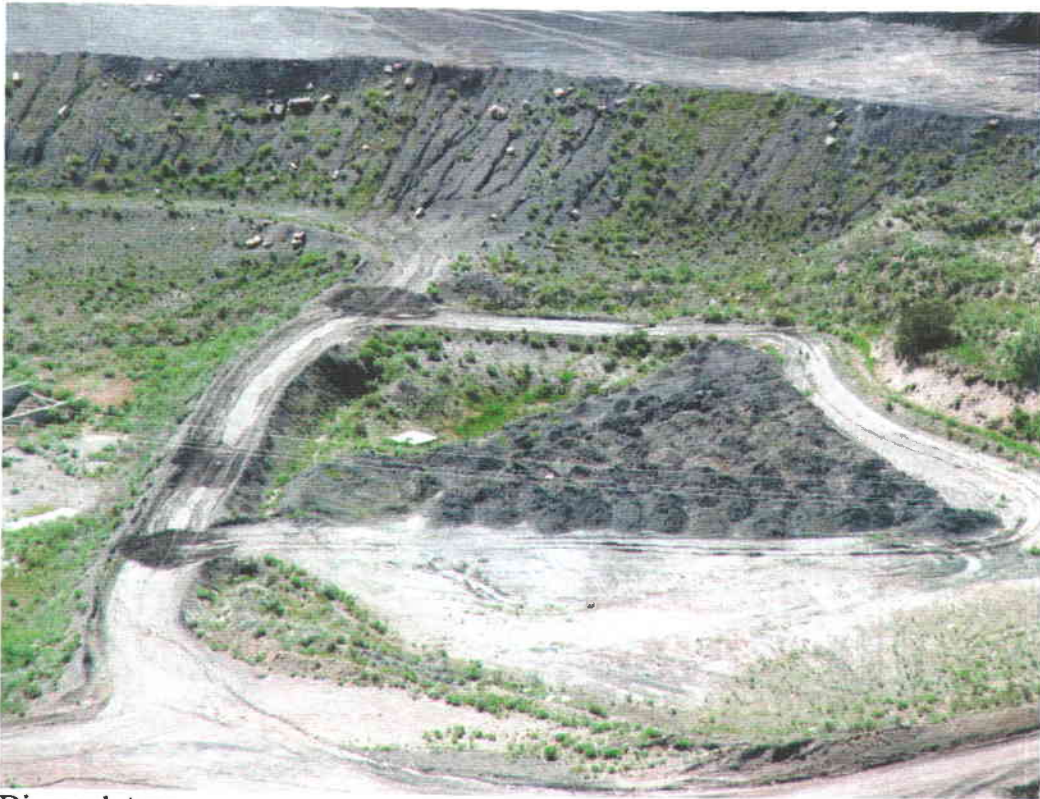
Disposal Area

No aspects of the Fill structure were observed that could affect its stability or functionality

The disposal area did not receive any materials during the quarter.

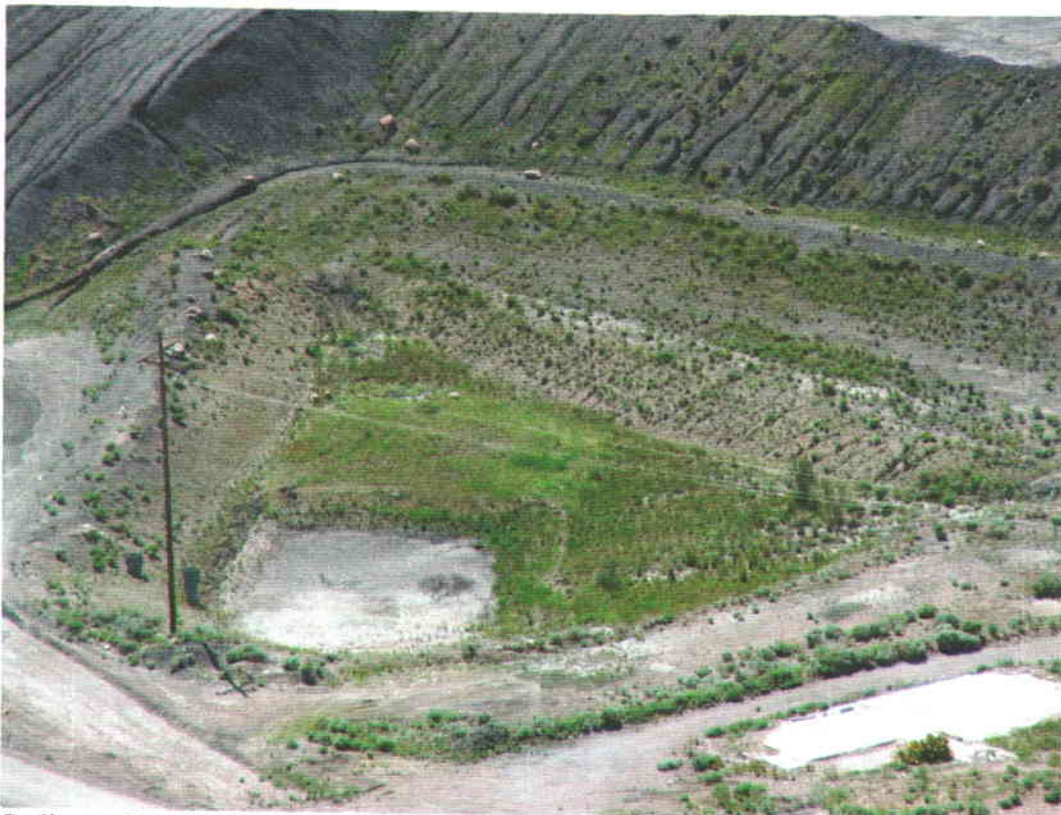
Sediment Pond #9

Pond had some water in it. No samples were taken. Pond did not require decanting.
Sediment levels were reasonably low.
Embankment conditions were good. Vegetation on out slopes was adequate.
Inlet / Outlet conditions were good. No structural or hazardous conditions were observed.

Sediment level was good.
